**Flood Control Project Maintenance  
Levee Inspections**

**Fall 2018 Levee Maintenance Deficiency Summary Report**

***San Joaquin River Basin***

**Reclamation District No. 2094 Walthall**

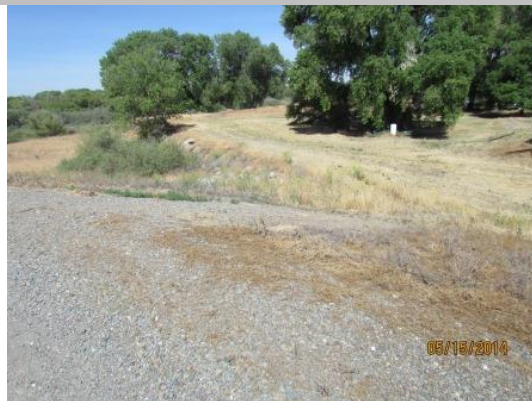
Photo 1 of 1 : FA\_2018\_RD2094\_320\_4\_20180906\_00001.jpg

LM Start	0.10	Rating **	M	Issue No.	4
LM End	0.10	Issue Type +	En	Location *	WS
Category	Earthen Levee			GPS Latitude/Longitude	
				Start	End
Item	Encroachments			37.771685 °	37.771685 °
				-121.300239 °	-121.300239 °
DWR ID	DWR_RD2094_01_s_2012_4				
Comment Code					
RA : Ramp					
Inspector Comment					
An access ramp has been built on the water side and extends into the channel. This could potentially alter the channel capacity. This item was also noted in the USACE comments.

Tire marks shown onto the ramp from levee. Raised area extends to the trees in the background in the center of the photo.

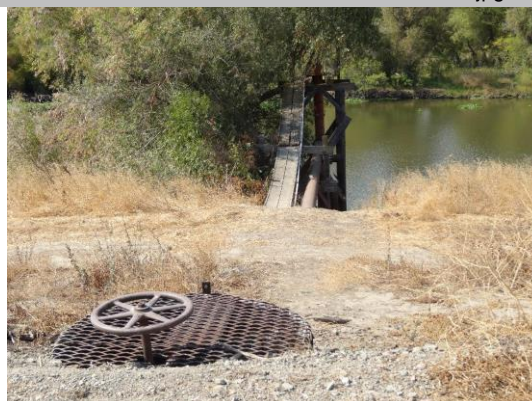
Photo 1 of 3 : UCIP\_FA\_2018\_21464\_36405.jpg

Comment Code					
Inspector Comment					
FS_ID:21464 DS_ID:23086 EP_NO: N/A Repair Type: Non-Urgent Crossing Status: Found UCIP Comments: - walkway in poor condition and needs repair.- electric conduit on waterside. FIELD_STRUCT_DESC: 14-inch concrete encased steel irrigation discharge pipe and galvanized iron (GI) electrical conduit through the levee, 10 feet below the crown. Two concrete cutoff walls. Pump mounted on a pile structure in the stream. Slide gate in a 54-inch corrugated metal pipe (CMP) riser on the waterside (WS) shoulder. Concrete distribution box and service pole at the landside (LS) toe. Installed by USACE in 1962. [Additional Reference(s): DWR Levee Log, 2005. USACE San Joaquin O&M Manual 3, December 1968, (HLM 0.66)]. FS Date: 9/10/2013

WS view: gate valve in CMP riser (bottom) and pipe & pump (top) on piling structure in the channel.

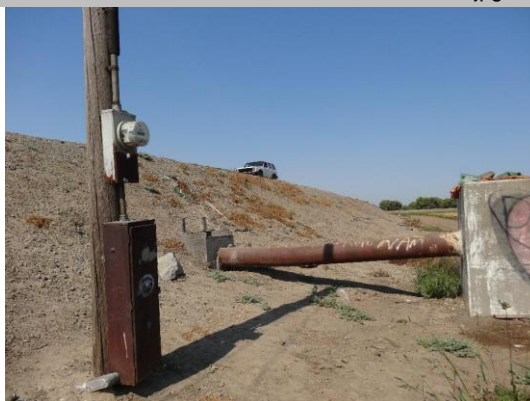
Photo 3 of 3 : UCIP\_FA\_2018\_21464\_36403.jpg

Comment Code						
Inspector Comment						
FS_ID:21464 DS_ID:23086 EP_NO: N/A Repair Type: Non-Urgent Crossing Status: Found UCIP Comments: - walkway in poor condition and needs repair.- electric conduit on waterside. FIELD_STRUCT_DESC: 14-inch concrete encased steel irrigation discharge pipe and galvanized iron (GI) electrical conduit through the levee, 10 feet below the crown. Two concrete cutoff walls. Pump mounted on a pile structure in the stream. Slide gate in a 54-inch corrugated metal pipe (CMP) riser on the waterside (WS) shoulder. Concrete distribution box and service pole at the landside (LS) toe. Installed by USACE in 1962. [Additional Reference(s): DWR Levee Log, 2005. USACE San Joaquin O&M Manual 3, December 1968, (HLM 0.66)]. FS Date: 9/10/2013

LS view: exposed pipe, service pole, and concrete distribution box on levee toe.

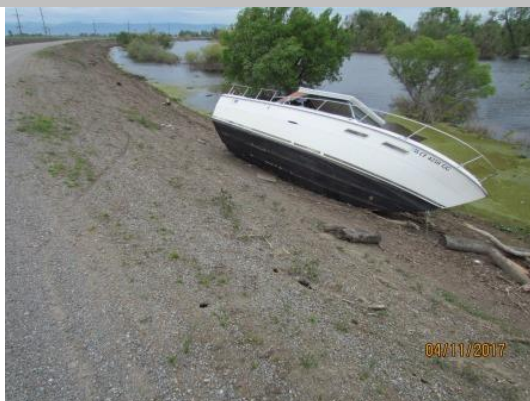
Photo 1 of 1 : FA\_2018\_RD2094\_320\_8\_20180906\_00002.jpg

LM Start	0.91	Rating **	M	Issue No.	8
LM End	0.91	Issue Type +	En	Location *	WS
Category	Earthen Levee			GPS Latitude/Longitude	
				Start	End
Item	Encroachments			37.764169 °	37.764169 °
				-121.293562 °	-121.293562 °
DWR ID	DWR_RD2094_01_s_2017_8				
Comment Code					
AV : Abandoned vehicles					
Inspector Comment					
Remove boat from the levee slope.

View of the boat on the levee slope.

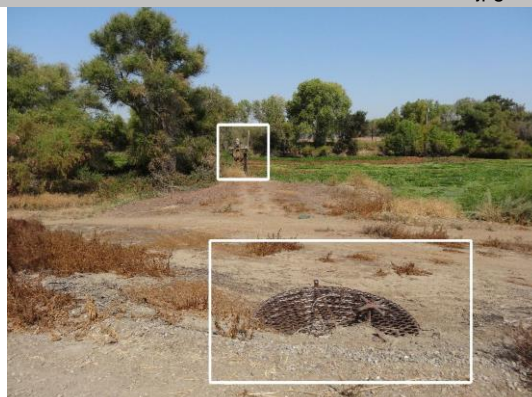
Photo 1 of 3 : UCIP\_FA\_2018\_21544\_36524.jpg

Comment Code						
Inspector Comment						
FS_ID:21544						
DS_ID:23087						
EP_NO: N/A						
Repair Type: Non-Urgent						
Crossing Status: Found						
UCIP Comments: - working as drainage system during field visit. Pump concrete cutoff walls. Pump mounted on a pile structure in the stream. was not running.- electric conduit on WS- open pipe end in CMP riser. CMP needs cleaning.						
FIELD_STRUCT_DESC: 20-inch concrete encased steel irrigation discharge pipe through the levee, 10 feet below the crown. Two concrete cutoff walls. Pump mounted on a pile structure in the stream. Slide gate in a 54-inch corrugated metal pipe (CMP) riser on the waterside (WS) shoulder. Concrete distribution box and service pole at the landside (LS) toe. [Additional Reference(s): DWR Levee Log, 2005. USACE San Joaquin O&M Manual 3, December 1968, (HLM 1.27)].						
FS Date: 9/10/2013

WS view: overview of pump (top) and CMP riser (bottom)

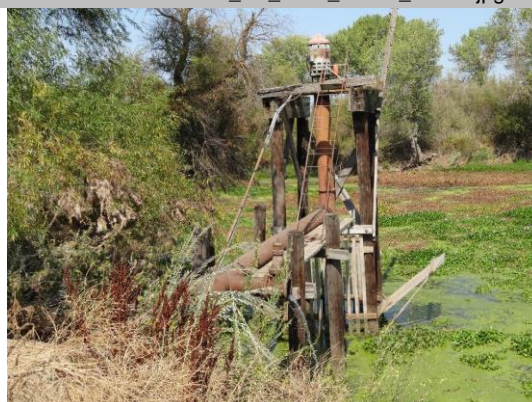
Photo 2 of 3 : UCIP\_FA\_2018\_21544\_36523.jpg

WS view: pipe and pump on piling structure in the channel. Walkway in poor condition.

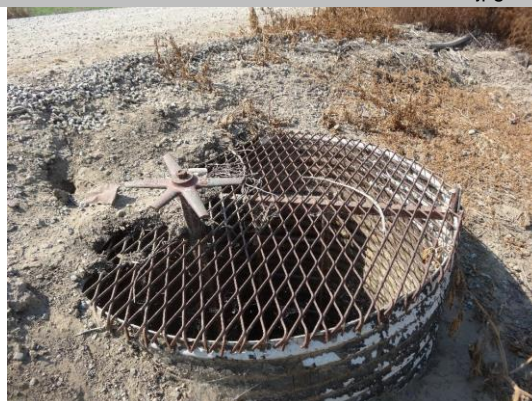
Photo 3 of 3 : UCIP\_FA\_2018\_21544\_36522.jpg

Comment Code						
Inspector Comment						
FS_ID:21544 DS_ID:23087 EP_NO: N/A Repair Type: Non-Urgent Crossing Status: Found UCIP Comments: - working as drainage system during field visit. Pump was not running.- electric conduit on WS- open pipe end in CMP riser. CMP needs cleaning. FIELD_STRUCT_DESC: 20-inch concrete encased steel irrigation discharge pipe through the levee, 10 feet below the crown. Two concrete cutoff walls. Pump mounted on a pile structure in the stream. Slide gate in a 54-inch corrugated metal pipe (CMP) riser on the waterside (WS) shoulder. Concrete distribution box and service pole at the landside (LS) toe. [Additional Reference(s): DWR Levee Log, 2005. USACE San Joaquin O&M Manual 3, December 1968, (HLM 1.27)]. FS Date: 9/10/2013

WS view: damaged gate valve handle in CMP riser on levee shoulder.

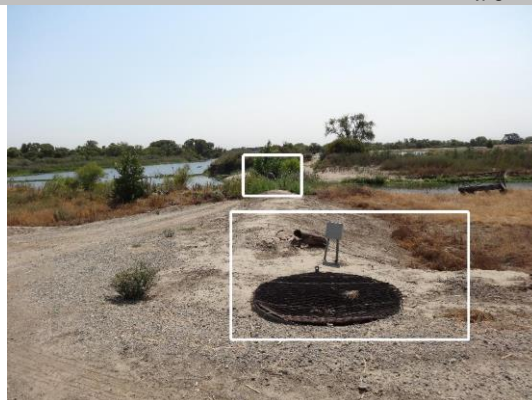
Photo 1 of 3 : UCIP\_FA\_2018\_41726\_36502.jpg

Comment Code						
Inspector Comment						
FS_ID:41726 DS_ID:23088 EP_NO: N/A Repair Type: Non-Urgent Crossing Status: Found UCIP Comments: - dense vegetation on WS.- working during field survey.- slide gate not found on WS. FIELD_STRUCT_DESC: 20-inch concrete encased steel irrigation discharge pipe through the levee, 6 feet below the crown. Two concrete cutoff walls. Slant pump mounted on a frame structure on the stream bank. Slide gate in a 54-inch corrugated metal pipe (CMP) riser on the waterside (WS) shoulder. Concrete distribution box and service pole at the landside (LS) toe. [Additional Reference(s): DWR Levee Log, 2005. USACE San Joaquin O&M Manual 3, December 1968, (HLM 2.30)]. FS Date: 9/10/2013

WS view: slant pump (top) on stream bank and CMP riser on levee shoulder.

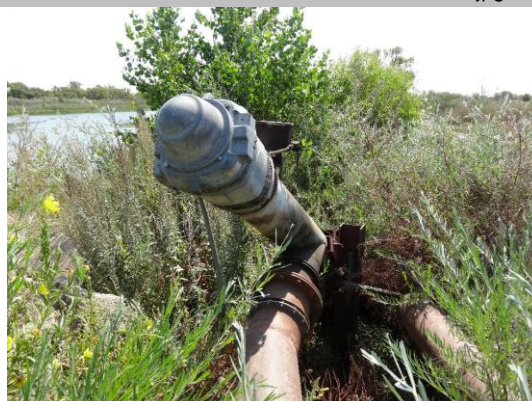
Photo 2 of 3 : UCIP\_FA\_2018\_41726\_36501.jpg

WS view: slant pump on stream bank and dense vegetation on stream bank.

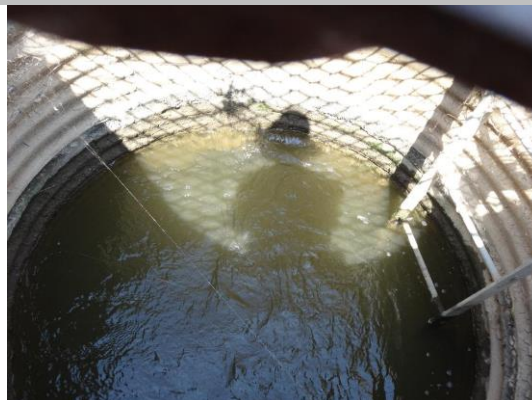
Photo 3 of 3 : UCIP\_FA\_2018\_41726\_36500.jpg

Comment Code						
Inspector Comment						
FS_ID:41726 DS_ID:23088 EP_NO: N/A Repair Type: Non-Urgent Crossing Status: Found UCIP Comments: - dense vegetation on WS.- working during field survey.- slide gate not found on WS. FIELD_STRUCT_DESC: 20-inch concrete encased steel irrigation discharge pipe through the levee, 6 feet below the crown. Two concrete cutoff walls. Slant pump mounted on a frame structure on the stream bank. Slide gate in a 54-inch corrugated metal pipe (CMP) riser on the waterside (WS) shoulder. Concrete distribution box and service pole at the landside (LS) toe. [Additional Reference(s): DWR Levee Log, 2005. USACE San Joaquin O&M Manual 3, December 1968, (HLM 2.30)]. FS Date: 9/10/2013

WS view: inside view of CMP riser on levee shoulder. No slide gate found.

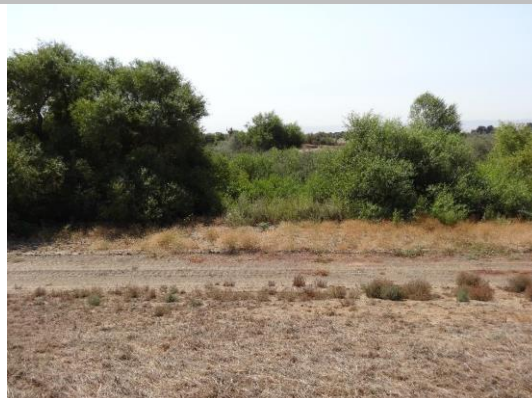
Photo 1 of 3 : UCIP\_FA\_2018\_21545\_36529.jpg

LM Start	2.45	Rating **	M	Issue No.	16
LM End	2.45	Issue Type +	En	Location *	
Category	Supplemental			GPS Latitude/Longitude	
				Start	End
Item	DWR UCIP Field Study			37.752308 °	37.752308 °
				-121.293191 °	-121.293191 °
DWR ID	23089				
Comment Code					
Inspector Comment					
FS_ID:21545 DS_ID:23089 EP_NO: N/A Repair Type: Non-Urgent Crossing Status: Found UCIP Comments: - no pipes found on either side of the levee.- concrete distribution box on LS. Soil erosion around distrinution box. FIELD_STRUCT_DESC: Rectangular concrete distribution box on the landward toe FS Date: 9/10/2013

WS view: no pipe found on waterside.

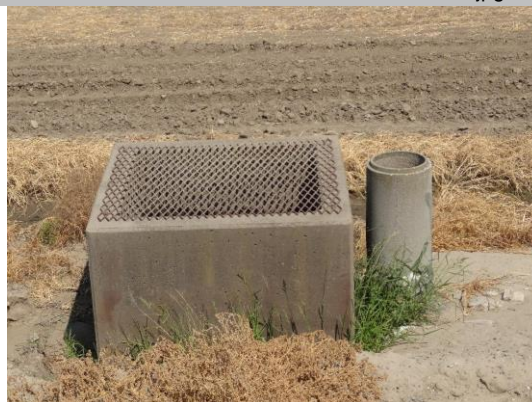
Photo 2 of 3 : UCIP\_FA\_2018\_21545\_36528.jpg

LS view: erosion around a concrete standpipe on the landside toe.

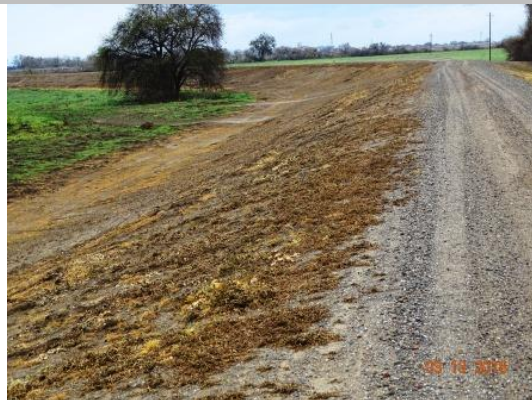
Photo 1 of 1 : FA\_2018\_RD2094\_321\_1\_20181127\_00001.jpg

LM Start	0.08	Rating **	A	Issue No.	1
LM End	0.42	Issue Type +	Ma	Location *	WS
Category	Earthen Levee			GPS Latitude/Longitude	
				Start	End
Item	Vegetation			37.759842°	37.760621°
				-121.300809°	-121.306804°
DWR ID	DWR_RD2094_02_f_2018_1				
Comment Code					
V1 : Control annual grass and weeds on the levee slopes and easements.					
Inspector Comment					
Acceptable vegetation control.

View of the acceptable vegetation control on the levee slope.
